Ride-Rite™ Warranty Evaluation Guide

WARRANTY GUIDE

Firestone air springs are designed and built to the highest of standards and will provide years and thousands of miles of trouble-free service. Most failures are caused by improper application, installation, misuse, and abuse. The following examples are common failures that are NOT covered under warranty.

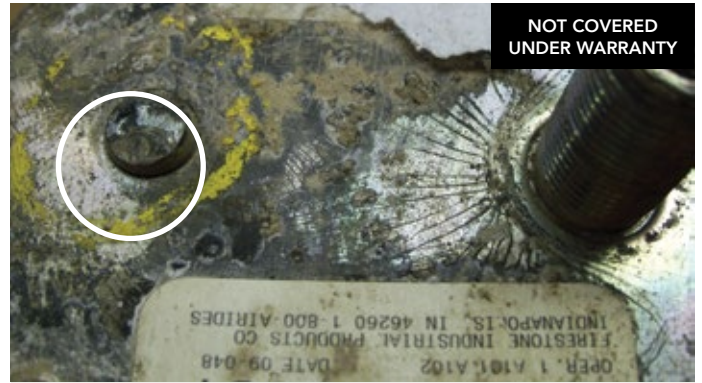
Bent Alignment Pin

Convuluted shown

- One side of alignment pin is pushed down toward the bead plate
- Marring or semicircular gouge in the top of the alignment pin
- Pin pushed in

- Alignment pin was not installed into the alignment pin hole in the bracket
- Attachment hardware not tightened

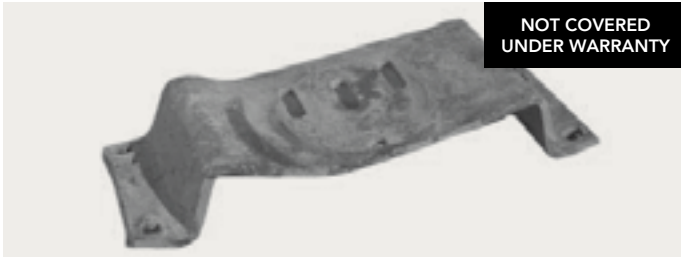
Bent or Broken Brackets & Bolts

- Distorted shape
- Possible cracking or "tearing"

- Not enough air pressure in the system for the load
- Overloading the vehicle/air springs
- Bottoming out

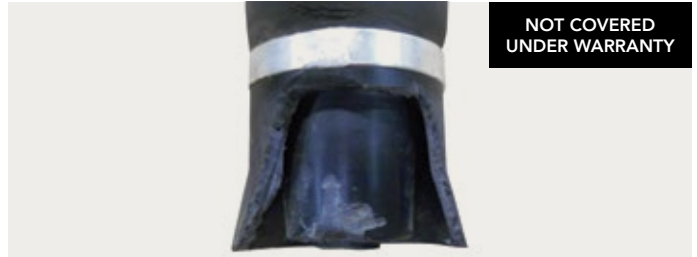
Broken Piston

- Cracked or broken piston

- Road debris
- Not enough pressure in the system for the load
- Overloading the vehicle/air springs
- Installed height of air spring too short
- Bottoming out

Bottom of tapered sleeve shown (Sport-Rite™ application).

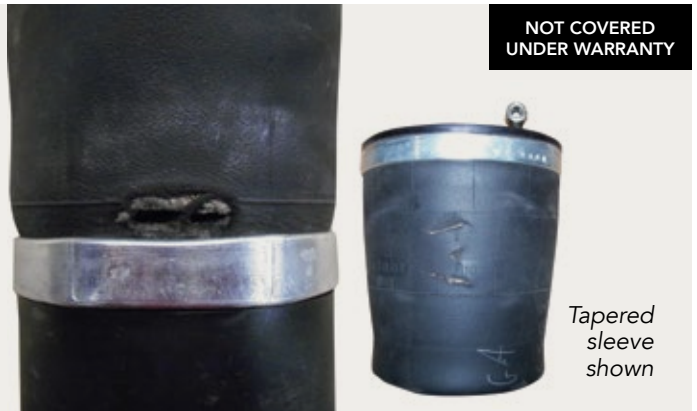
Bottoming Out

- Bent brackets or beadplates
- Broken girdle hoop (convoluted parts), caps or pistons (sleeve parts)
- Cuts near the bead plates, caps, or pistons
- Leaking around blind nuts

- Installation height is too low, resulting in air spring too short
- Not maintaining the minimum air pressure
- Not enough air pressure for the load
- Overloading the vehicle/air springs

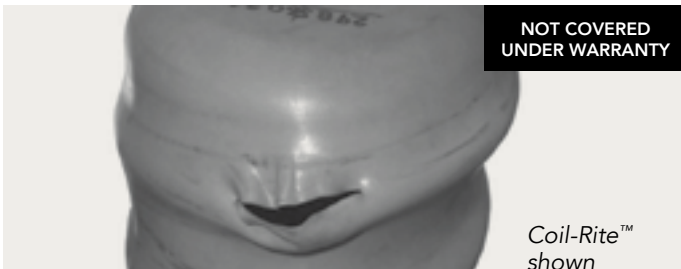
High Temperature / Over Inflation

- Tear in the side of the part, material seems thin or "stretched"

- Exposed to high temperature for long periods of time (too close to exhaust)
- Over inflation (see manual for max operating pressure)
